## Let There Be Light: The Palmer House Chandelier Restorations.

By Lee Balgemann

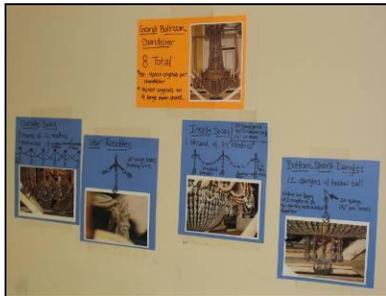
MAPPING AND CATALOGING follow. 80,000 crystals, many different sizes of different cuts, took up three rooms and were up to five layers deep on tables! Once again as the crystals were taken from the chandeliers, SAFETY was an issue. The workers wore face masks to keep pollutants and up to 80 years of nicotine and other debris from contaminating them. Each crystal was labeled and mapped as to where it

was on the chandelier so it could be returned after cleaning and polishing.

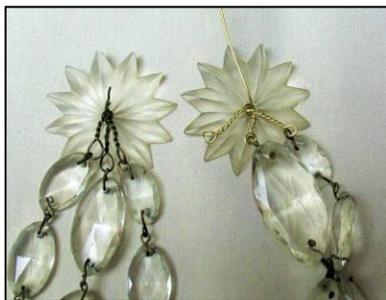
CRYSTAL RESTORATION provided new challenges. Re-wiring of the swags provided additional challenges, due to their varying weights, each crystal required a unique wiring procedure. After cleaning and repair, each crystal chain had to be “rinsed.” Broken crystals were repaired or replaced.

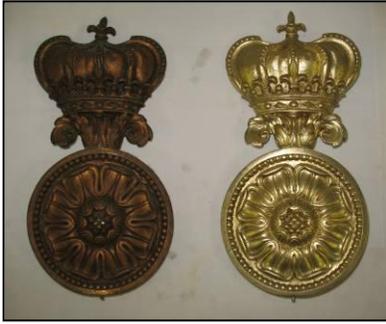
BRASS RESTORATION involved its own unique techniques. Small cracks and crevices had to be cleaned ultrasonically. Repairing of cracks, replacement of threading where necessary and the Electronic Discharge Machining of screw heads corroded away by galvanic corrosion were necessary on many chandelier parts. Concealed damage of inner components caused by a water leak from the swimming pool above the ballroom, also needed to be corrected. Cleaned, polished and restored brass returned the original beauty to the chandeliers.

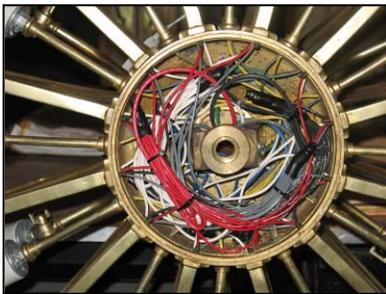
ELECTRICAL REPLACEMENT/RESTORATION/UL UPGRADING was incredibly time-consuming. Ground wires missing or not acceptably connected to the chandelier bodies, exposed wires, cloth wires held in place with wire twists, and corroded sockets all needed attention. All existing wiring was completely stripped from the chandeliers and replaced with new 105-degree C Teflon insulated wiring.

It was then necessary to connect and dress the 4 circuit “rat’s nests” in each chandelier before new sockets could replace the existing ones long-overdue for replacement. Lumenelle uses only the highest quality sockets; never-the-less, Lumenelle inspects every new socket for manufacturer’s defects and discards questionable sockets. All fixtures restored by Lumenelle are brought up to the latest UL (Underwriter Laboratories) standards.
